Inspection Report

Property Address:
Moresnow lane
Danville Ky 40422

Tru Home Inspections LLC

Date: 3/23/2009	Time: 09:00 AM	Report ID: Homeowner-09
Property: Moresnow lane Danville Ky 40422	Customer: Mr. Pete Homeowner	Real Estate Professional: Best REP In Town Best Real Estate

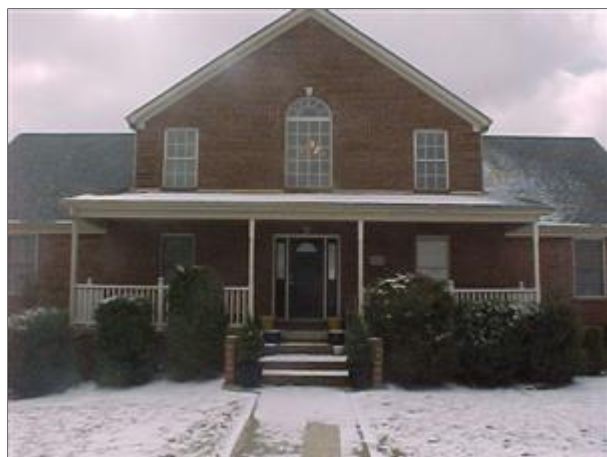
Front of home

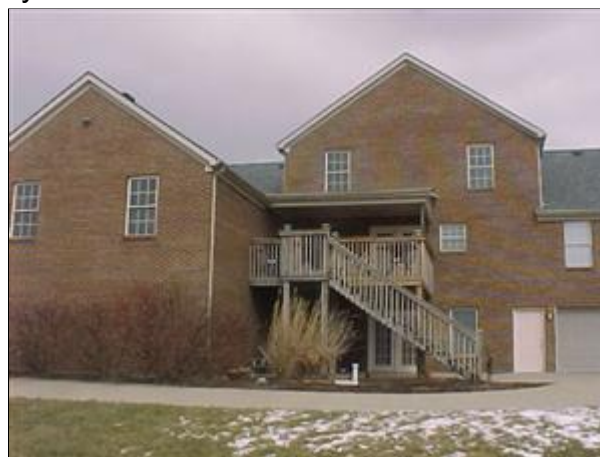
Rear of home

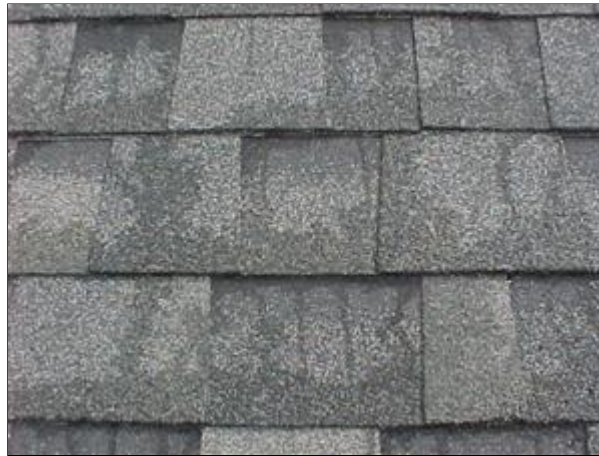
1.0 Picture 1 Roof

The roof covering is in very good condition. Between 2-5 yrs. old.

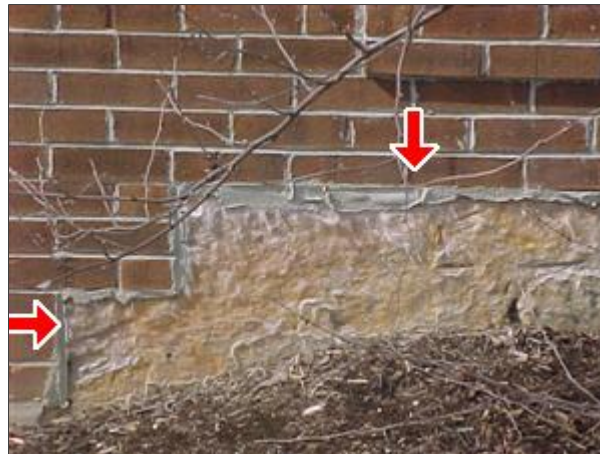
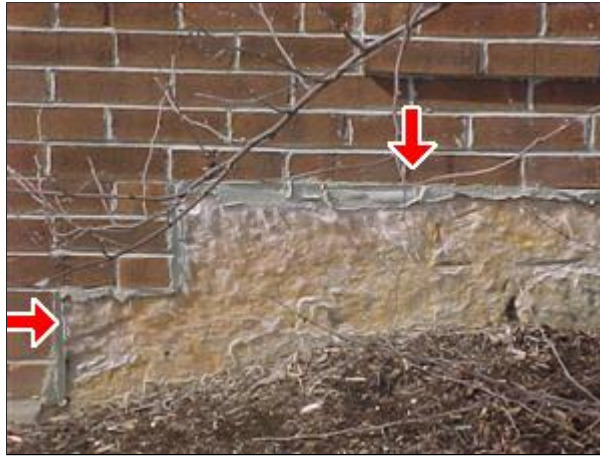
2.0 Picture 1 Left corner of home

The waterproofing is spalling away exposing the insulation underneath. This can cause water penetration into home. Recommend repair by a qualified mason or waterproofer.

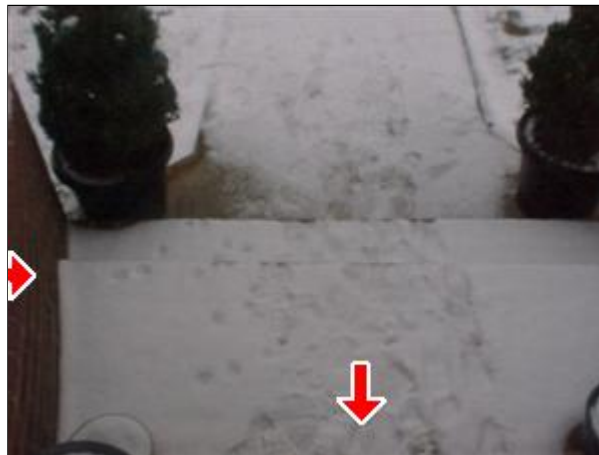
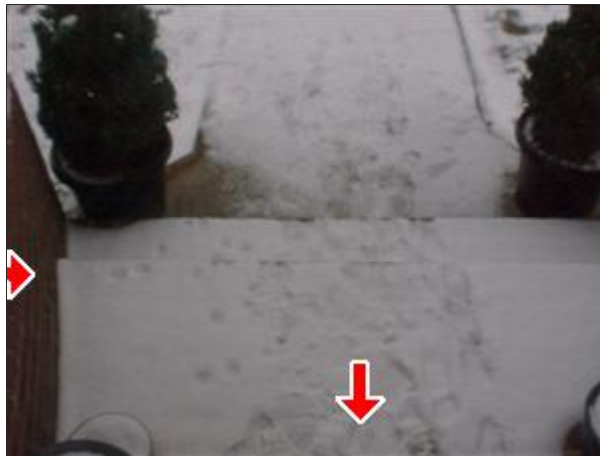
2.3 Picture 1 Photo of steps at entry.

This area at the entry of the home has a total of three steps and requires a handrail be installed. Recommend handrail be installed by a qualified contractor.

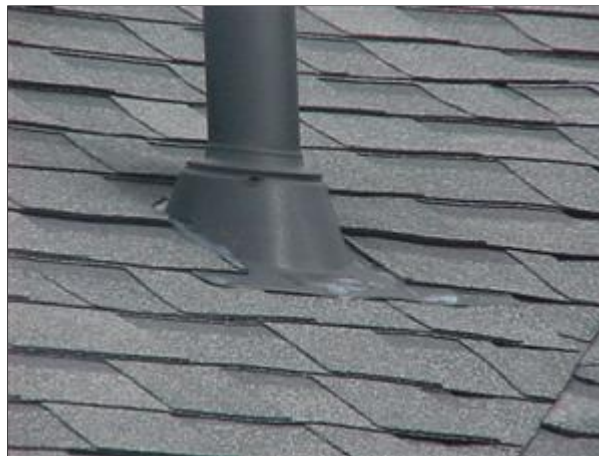
6.0 Picture 1 Main waste vent

Comments: Inspected
Vent for main system.

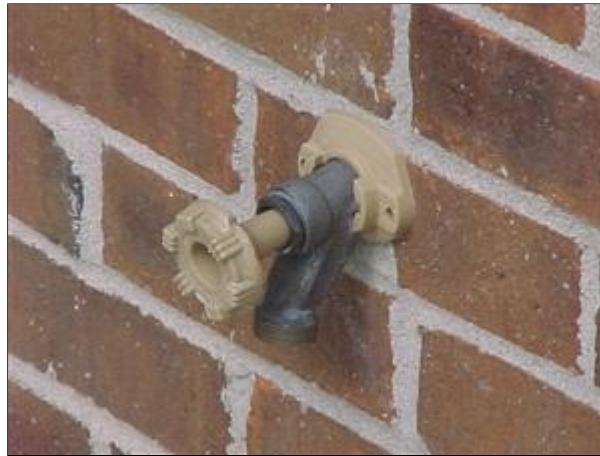
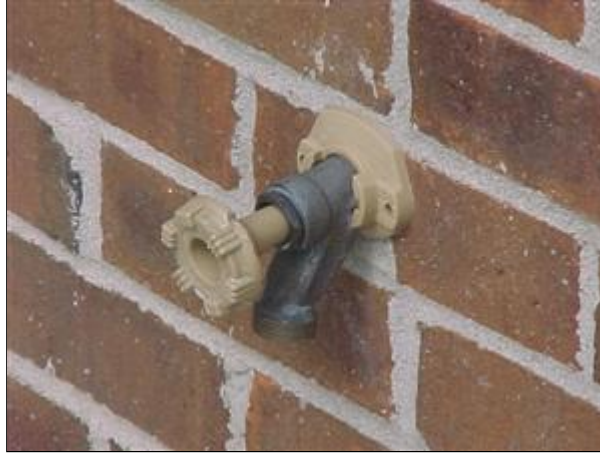
6.1 Picture 1

The hose bib turned off (winterized). We did not inspect this faucet or plumbing line at the rear of home.
